# Manhole Inspection Summary

Manhole # S41II\_037MH

**Location** Address: **DALLAS ST**

Cross Street: **BEHIND 1506 OLIVER ST**

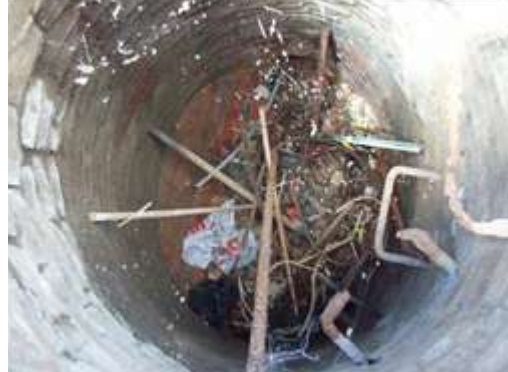
Top View

debris in channel

Comments **NEEDS CLEANING**

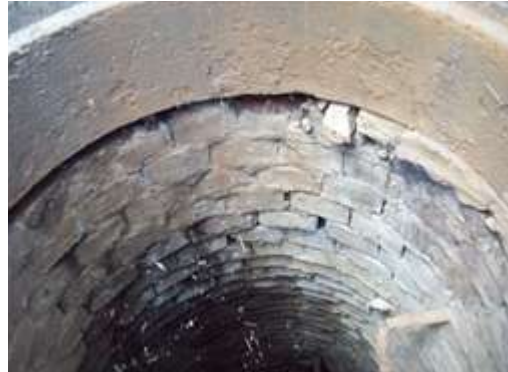
Defect 2

Condition: ☐ Sound ☒ **Cracked** ☐ Root Intrusion ☒ **Loose Brick** ☐ Deteriorated

Condition: ☐ Sound ☒ **Cracked** ☐ Root Intrusion ☐ Loose Brick ☐ Deteriorated

CRACKED AND LOOSE BRICKS in corbel and barrel

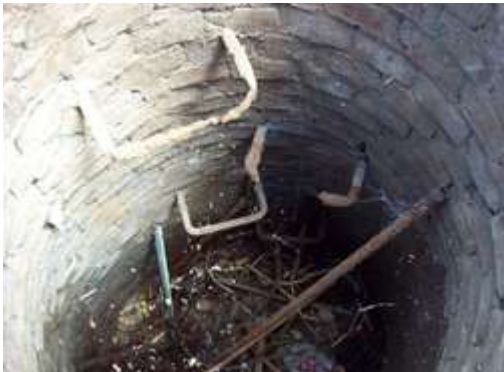
Defect 1

**Steps** Count: **3** Missing: **1** ☒ **Corroded**

CORRODED AND MISSING STEPS

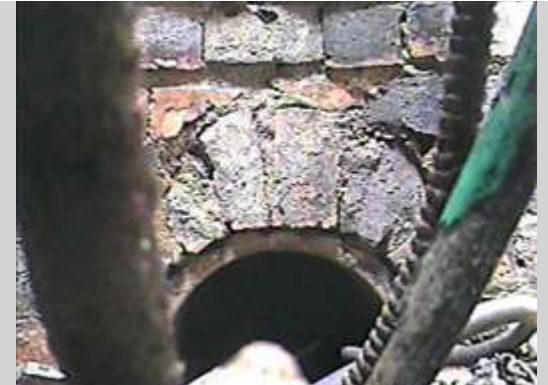
12 O'Clock Outflow

8 in. Circular Gravity Sewer  
Pipe Out @ 12 O'Clock
